***DOE/ID-10918
February 2002***

***Site 015 Track 1 Decision Documentation
Package, OU 10-08***

Site Description: Navy Debris in Canal Between TRA and NRF

Site ID: 015

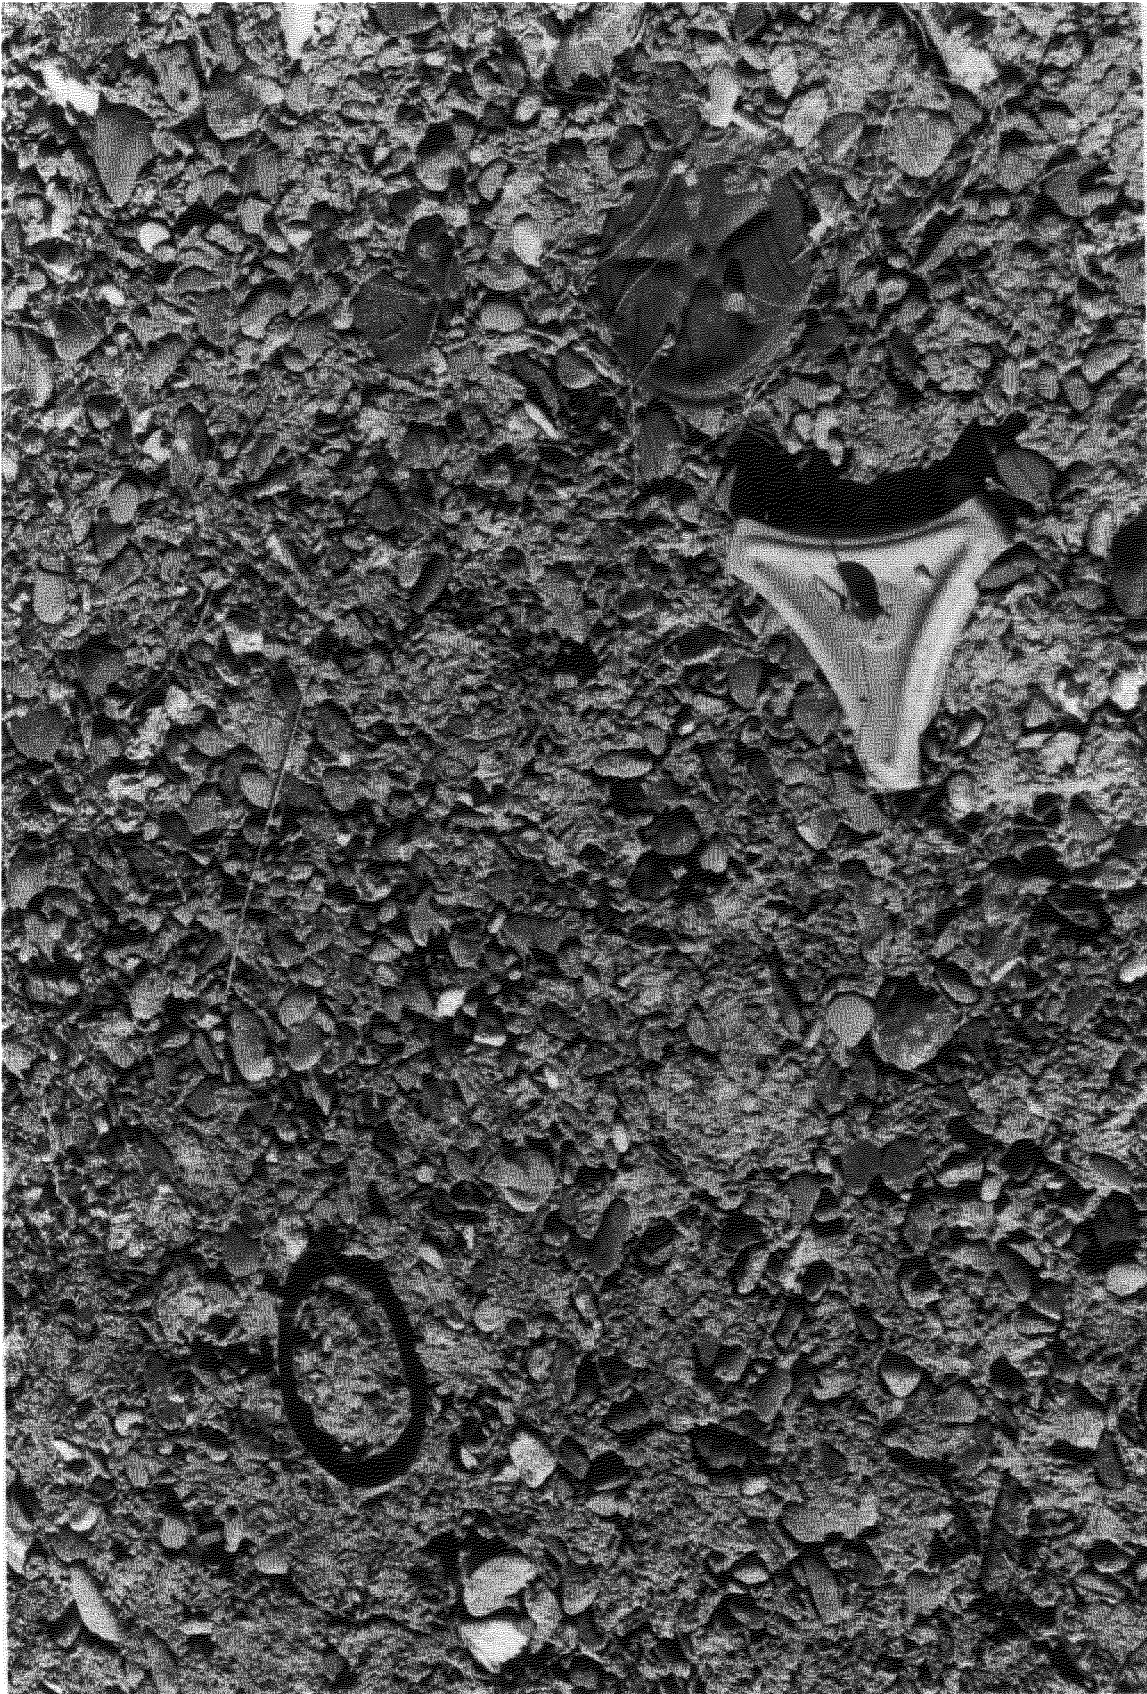
Site: 015, Navy Debris in Canal Between TRA and NRF
(99-465-1-21)

Site 015 consists of scattered surface debris located .25 miles inside a large canal starting at the intersection of roads T3 and T14 off Lincoln Boulevard proceeding north. The closest INEEL facility is the Naval Reactor Facility, located approximately 2-1/2 miles northeast. Surface debris consists of weathered triangular and round metal objects and rubber rings.

Discussions with an INEEL Environmental Restoration Environment Safety, and Health Quality Assurance (ER ES&HQA) explosives expert revealed that the artifacts are the remains of propellant cans, resulting from U.S. Navy testing during and post-World War II. The objects were determined to be inert, are not considered hazardous constituents, and as such, pose no risk to human health or the environment. INEEL Cultural Resources reviewed photographs and site investigations and verified the nature and age of the artifacts.

There is no visual evidence of hazardous constituents, nor evidence that waste has recently been disposed of at this site. There is no evidence of disturbed vegetation, stained or discolored soil, or odors. The groundcover is minimal, which is indicative of a dry canal bed, due to the amount of rocks, lack of nutrients, and compacted soil.

It is recommended that this newly identified site be classified as No Further Action. Field investigations, interviews, historical knowledge of this area, and photographs indicate it highly unlikely that hazardous or radioactive materials were generated or disposed of at this site. It is located in a remote, abandoned area with no viable pathways or receptors. The NRF is the closest facility located approximately 2-1/2 miles north. There is nothing present at this site that would indicate evidence of contaminant migration, or historical or threatened release of hazardous substances, pollutants or contaminants, and, as such poses no potential risk to human health or the environment.
